**Durant City Hall
Durant, OK
Remediation Final Report**

**Prepared by:
Department of Environmental Quality
707 North Robinson
Oklahoma City, Oklahoma 73101**

**The Oklahoma Department of Environmental Quality (DEQ) is pleased to
present the City of Durant with the
Final Remediation Report for the Durant City Hall.**

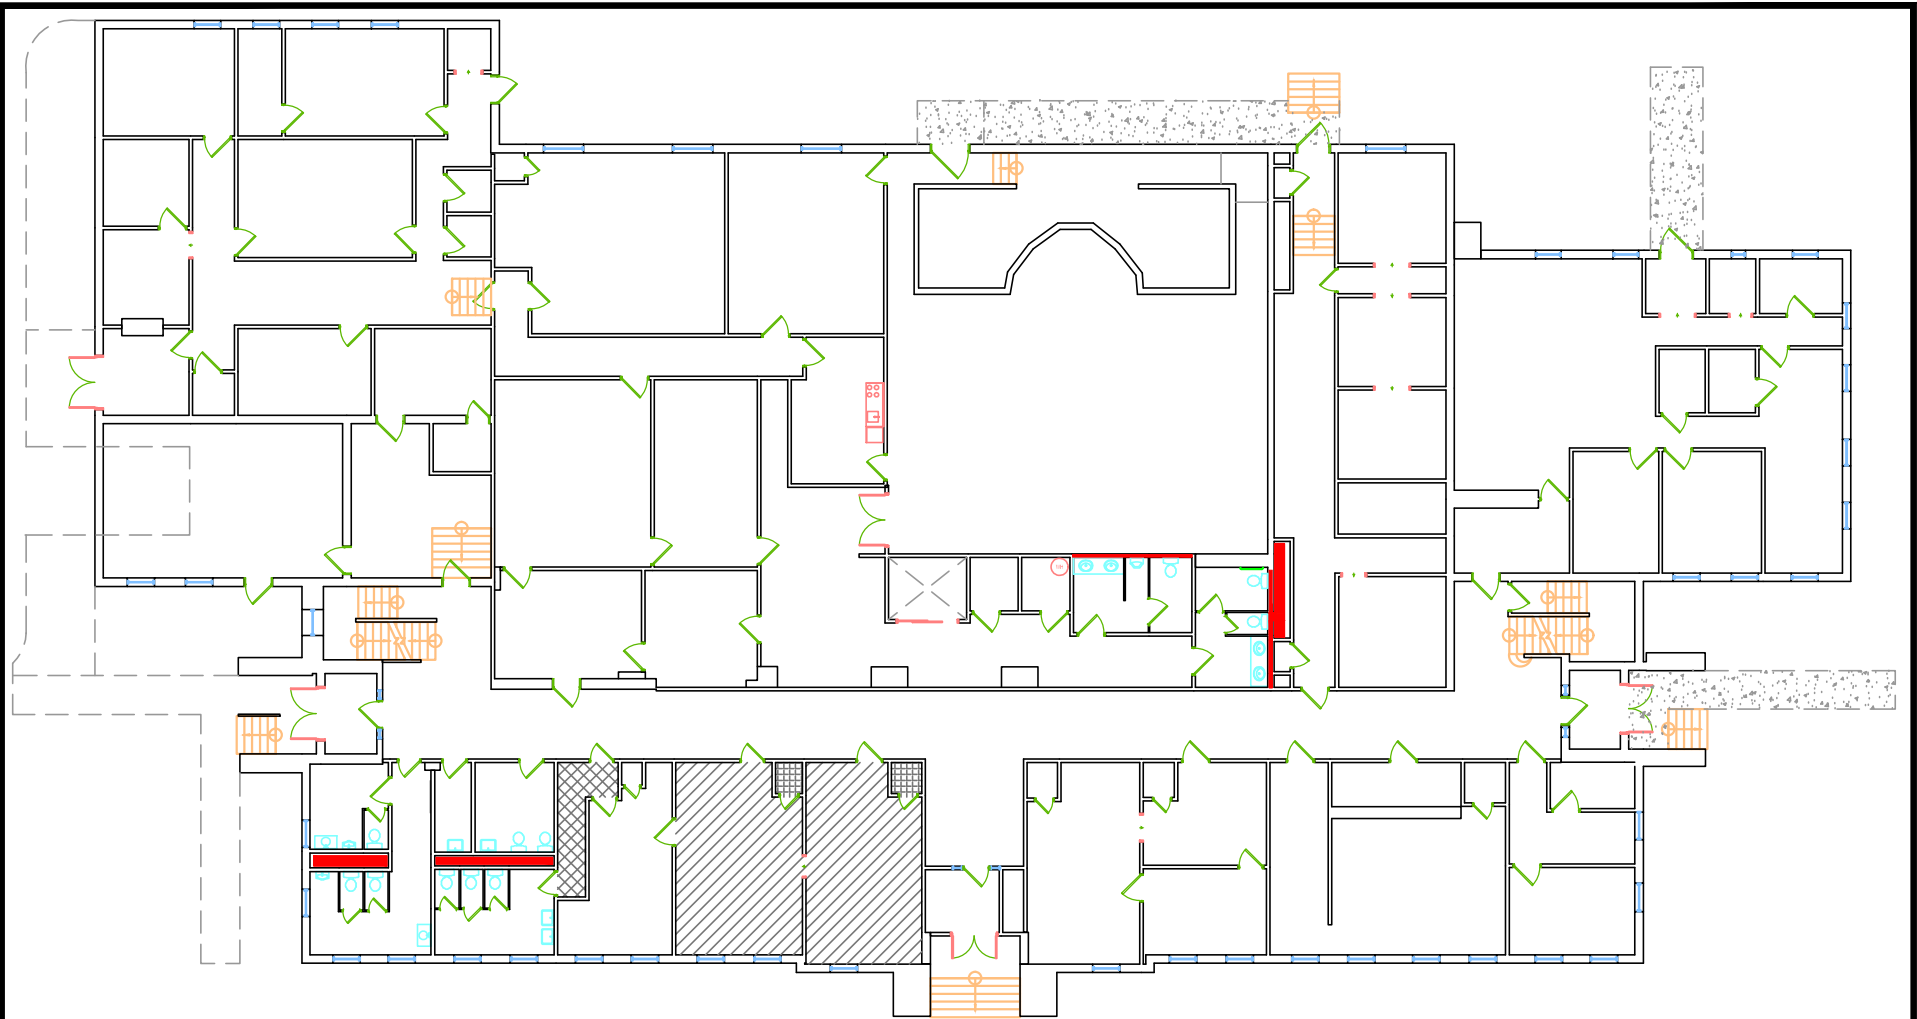
Asbestos Piping Locations
Basement and Crawl Space

1. Piping to second floor perimeter radiators enclosed and not accessible for inspection (locations not shown).
2. Piping to restrooms not accessible for inspection
3. Estimated Quantity of insulated piping @ 200 LF
4. Estimated wall demolition for access for abatement = 600 SF

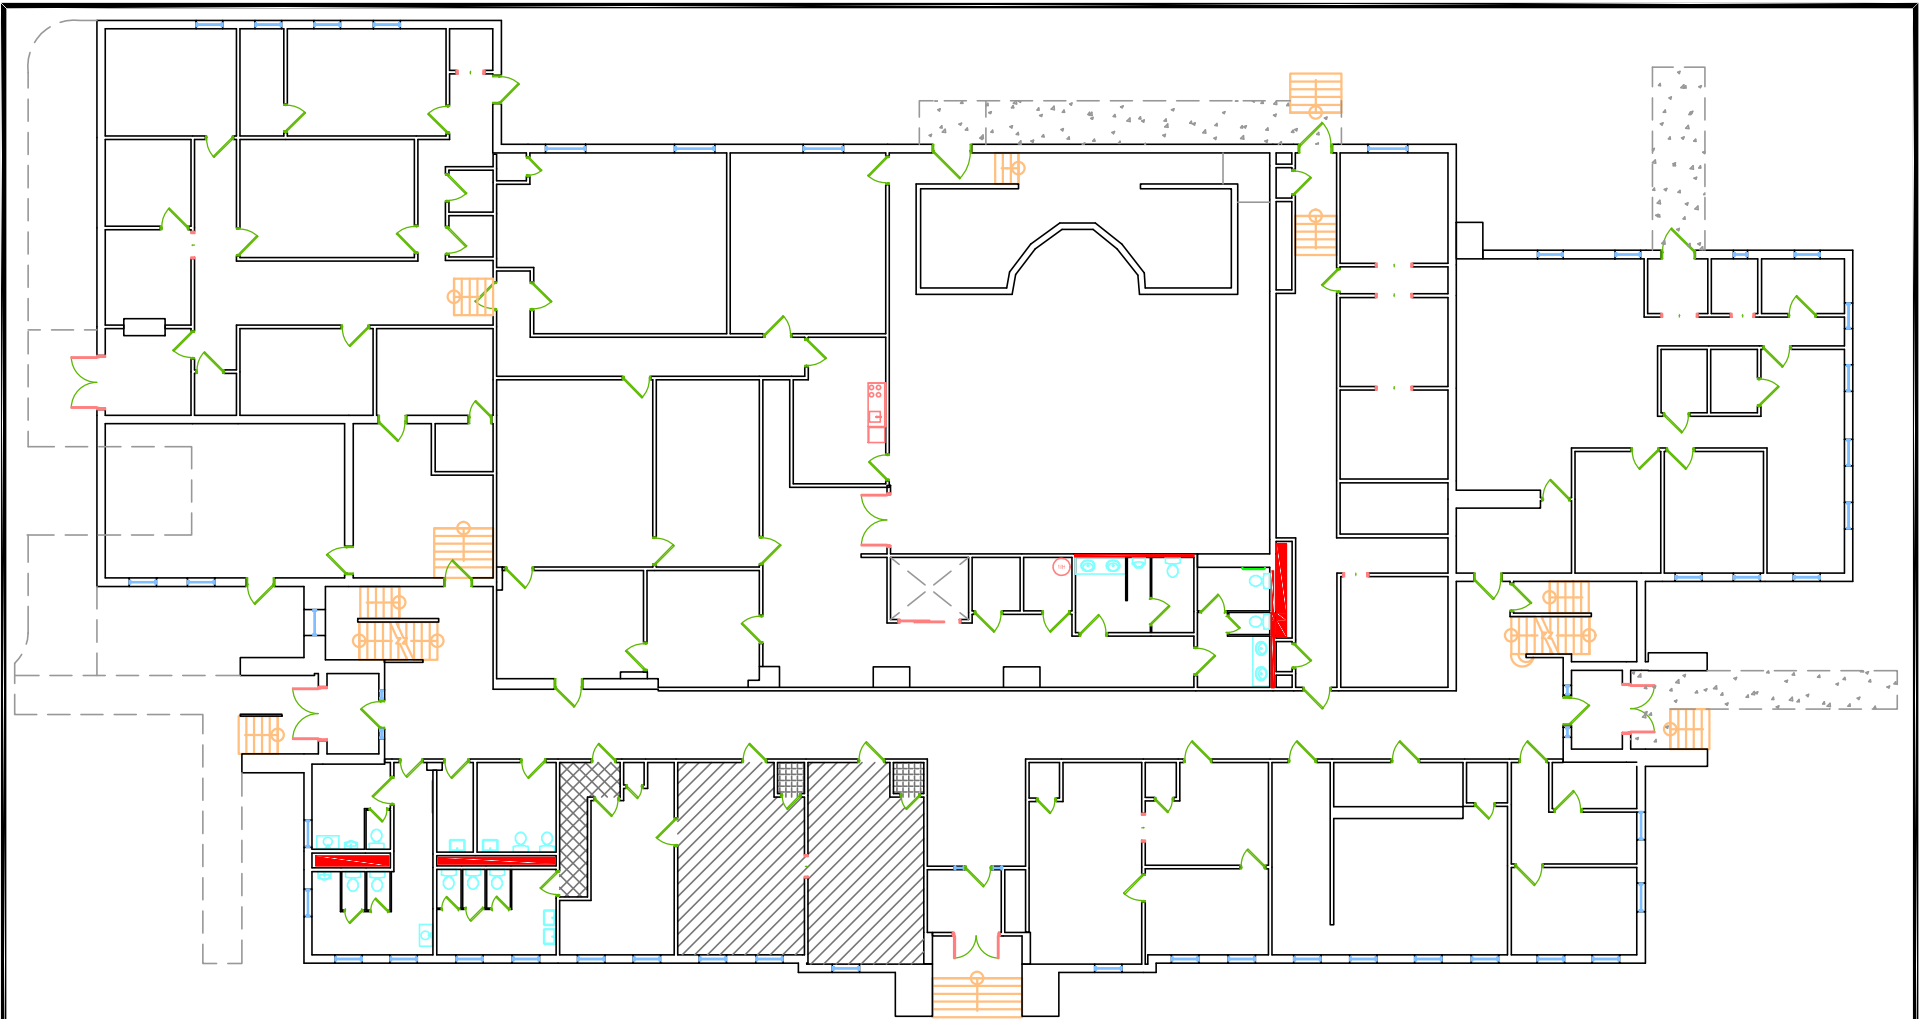
Sample Locations First Floor

1. Piping to second floor perimeter radiators enclosed and not accessible for inspection (locations not shown). 2. Piping to restrooms not accessible for inspection
3. Estimated Quantity of insulated piping @ 200 LF
4. Estimated wall demolition for access for abatement = 600 SF
