**Durant City Hall
Durant, OK
Remediation Final Report**

**Prepared by:
Department of Environmental Quality
707 North Robinson
Oklahoma City, Oklahoma 73101**

**The Oklahoma Department of Environmental Quality (DEQ) is pleased to
present the City of Durant with the
Final Remediation Report for the Durant City Hall.**

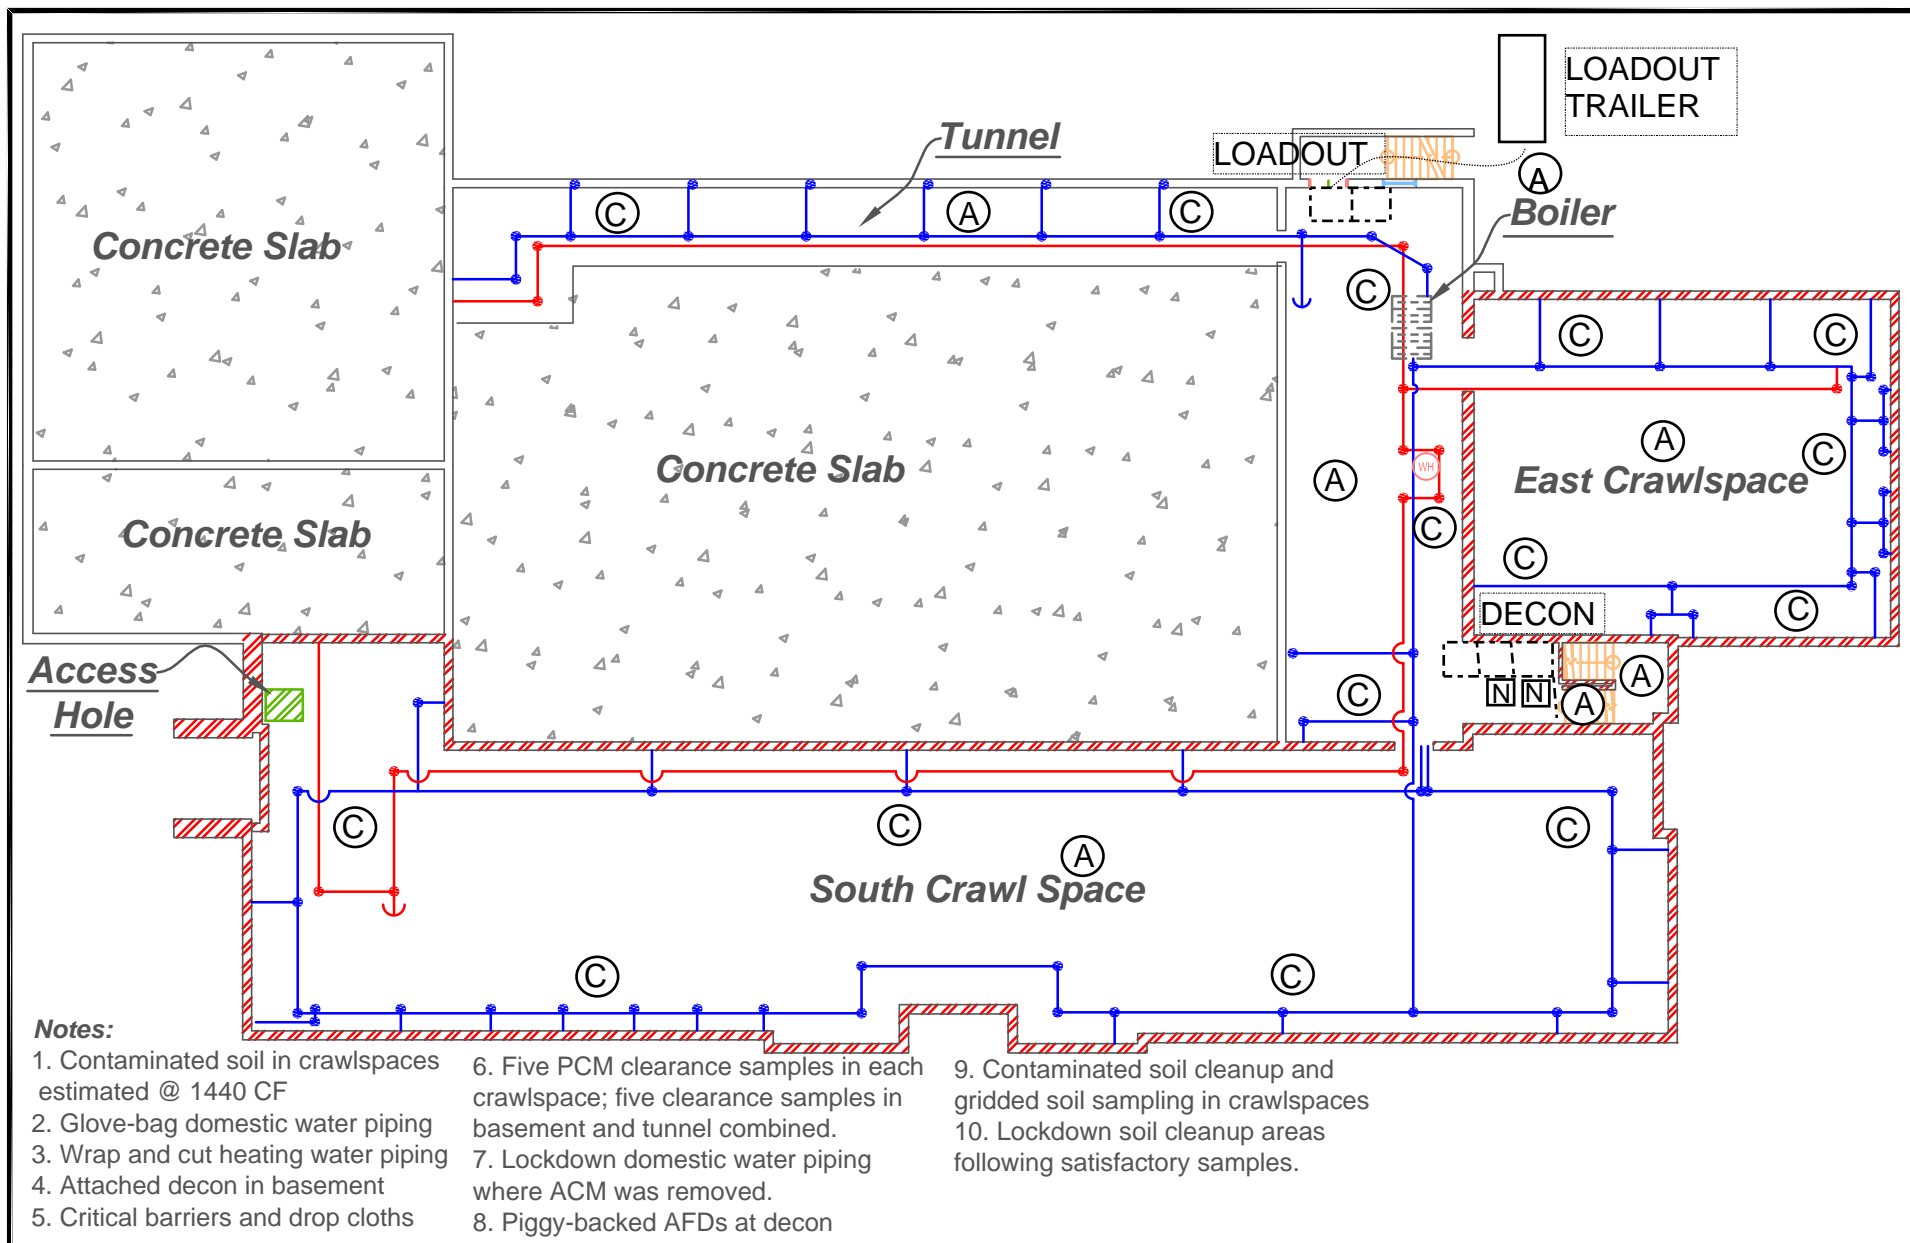
Asbestos Piping Locations
Basement and Crawl Space

The majority of the ACM-insulated piping is located in the basement boiler room, a pipe tunnel and two crawlspace that have some damaged insulation with contaminated soil beneath the piping runs. Access to these areas is limited. Piping from these areas penetrates the first floor to serve the original radiators on the first and second floors with the piping risers to the second floor enclosed along perimeter walls and presumed to be insulated in the same manner as that in the tunnel and crawlspace. Domestic water piping serving restrooms and other fixtures on the first and second floors is located inside walls/chases and is also presumed to be similarly insulated. Selective demolition will be necessary for access to this piping to confirm that it contains asbestos with additional demolition for access for abatement if the presence of asbestos is confirmed and abatement is undertaken. Estimated quantities have been included in the survey to enable planning for abatement of all asbestos in the building should that be the desired outcome of planned abatement.

Should complete abatement not be the selected option, the piping insulation in the basement, tunnel and crawlspace may be abated or repaired and managed in place. If all asbestos is not removed, preparation and implementation of an Asbestos Management Plan is recommended for management of the asbestos in place.
